CONNECTICUT CENTRAL COASTAL AREA
GUILFORD , CONNECTICUT

**MENUCKATUCK RESERVOIR DAM
CT-00408**

**PHASE I INSPECTION REPORT
NATIONAL DAM INSPECTION PROGRAM**

FEBRUARY 1980

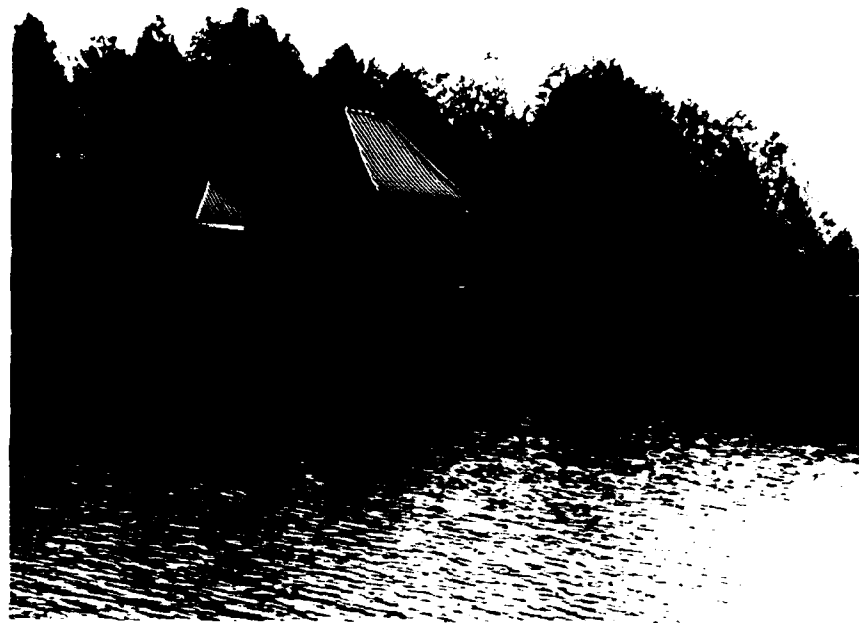
1) Upstream Face - The concrete face is in good condition as indicated in Photo No. 1 and Photo No. 2. Some spalling horizontally along the face at about the spillway elevation was noted (see Photo No. 3). Some efflorescence and discoloration of the concrete surface has occurred as indicated in Photo No. 3 and Photo No. 9 (apparently rust stains and high water marks). Generally the condition of the upstream face is good with no evidence of structural cracking or severe deterioration.

PHOTO #1: Upstream face of dam from right (west) abutment.

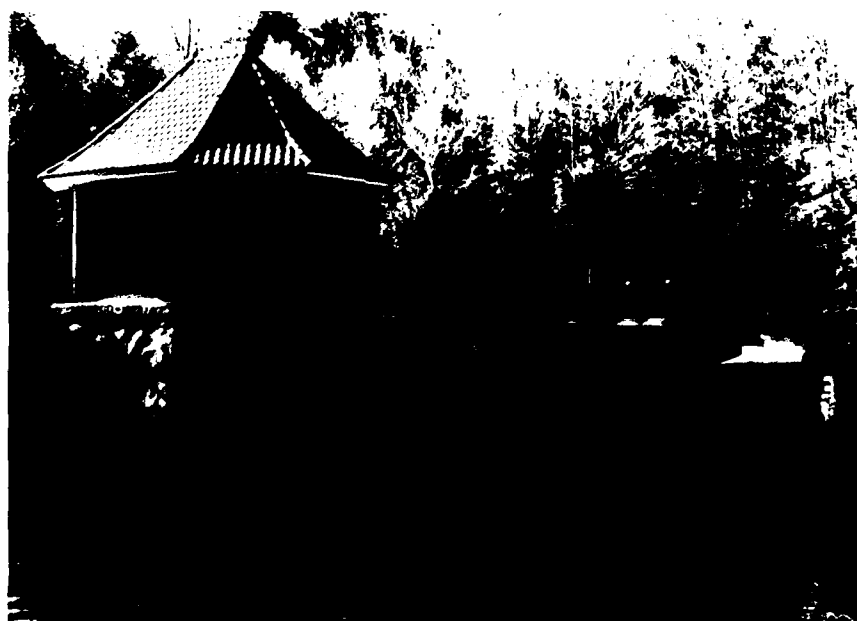
PHOTO #2: Upstream face of dam from left (east) abutment.

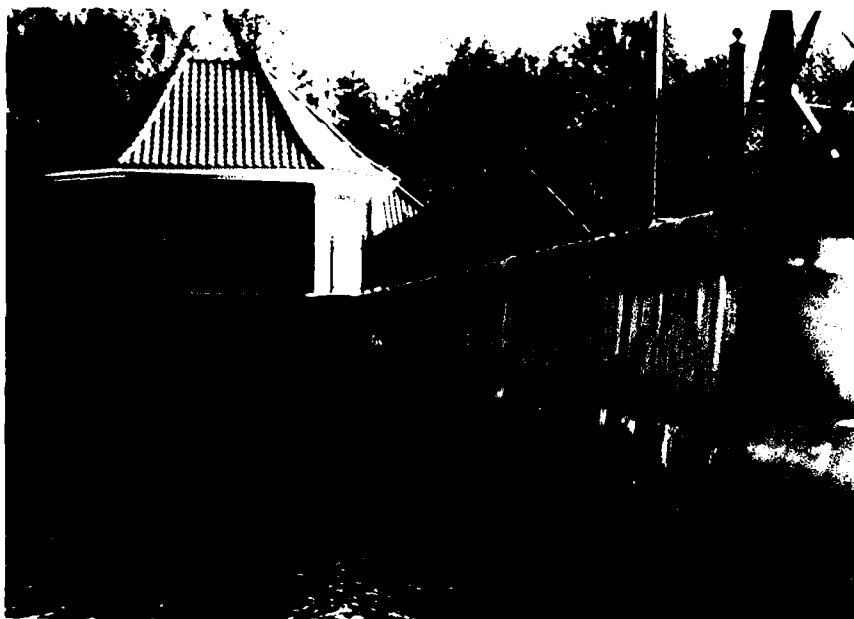
PHOTO #3: Upstream face of dam looking towards
left (east) abutment.

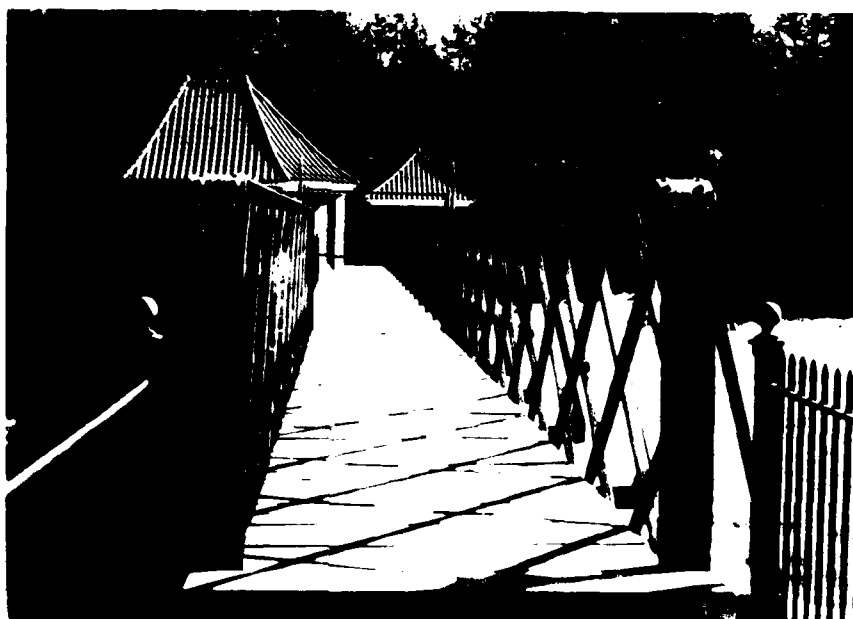
2) Crest - The crest is level and the concrete is in good condition. The vertical and horizontal alignment is good (Photo No. 4).

f. Footbridge. The metal truss of the service bridge is in good condition. Only minor rusting has occurred. The wood planking on the bridge is in excellent condition (Photo No. 4 and Photo No. 11).

PHOTO #4: Crest of dam from right (west) abutment.

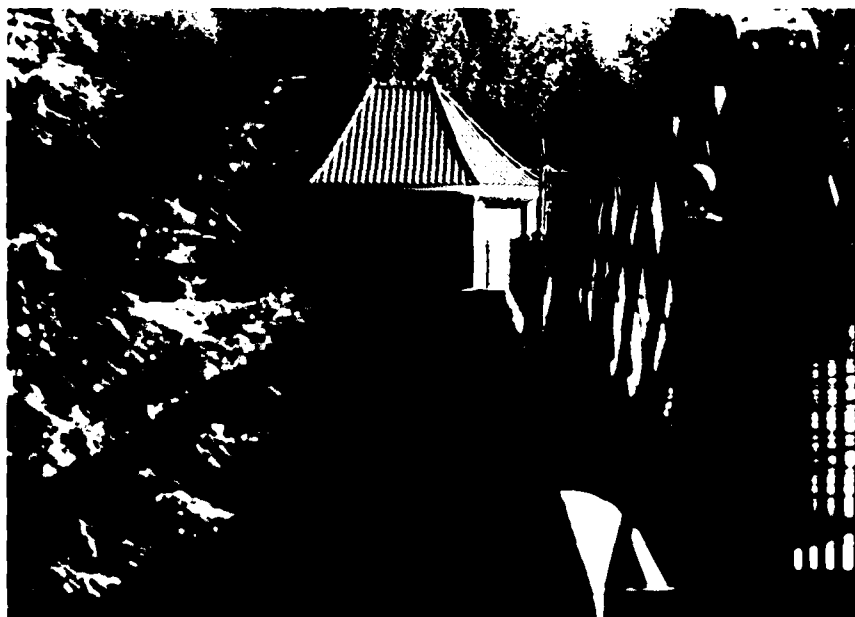
PHOTO #8: Upstream face from right (west) abutment.

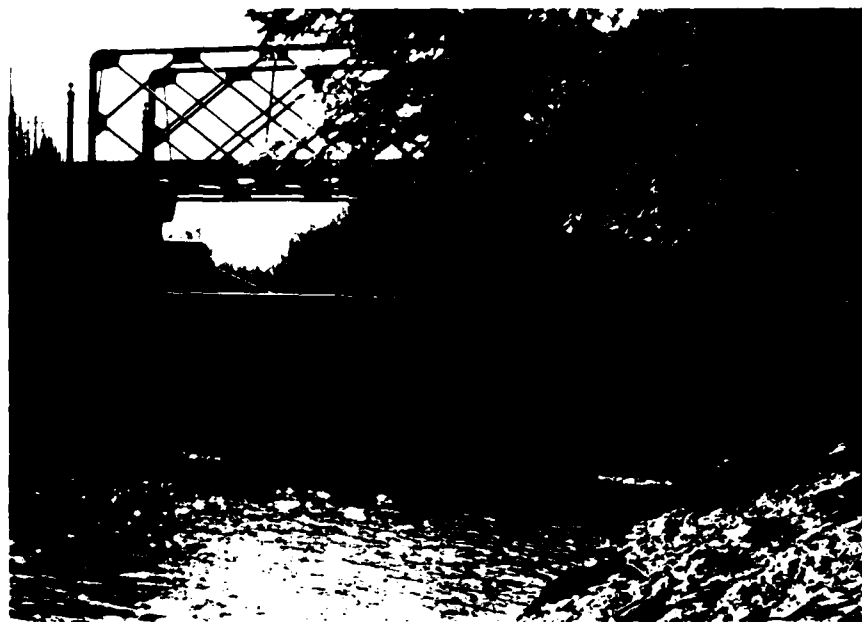
PHOTO #10: Approach to spillway weir.
